**NORWAY/UNITED STATES DESIGN PROTECTIVE
AIRCRAFT SHELTER (PAS) QUANTITY-DISTANCE
PROGRAM 1/3-SCALE TEST SERIES**

**Volume I of V
PAS 1-4 Summary**

Final Report

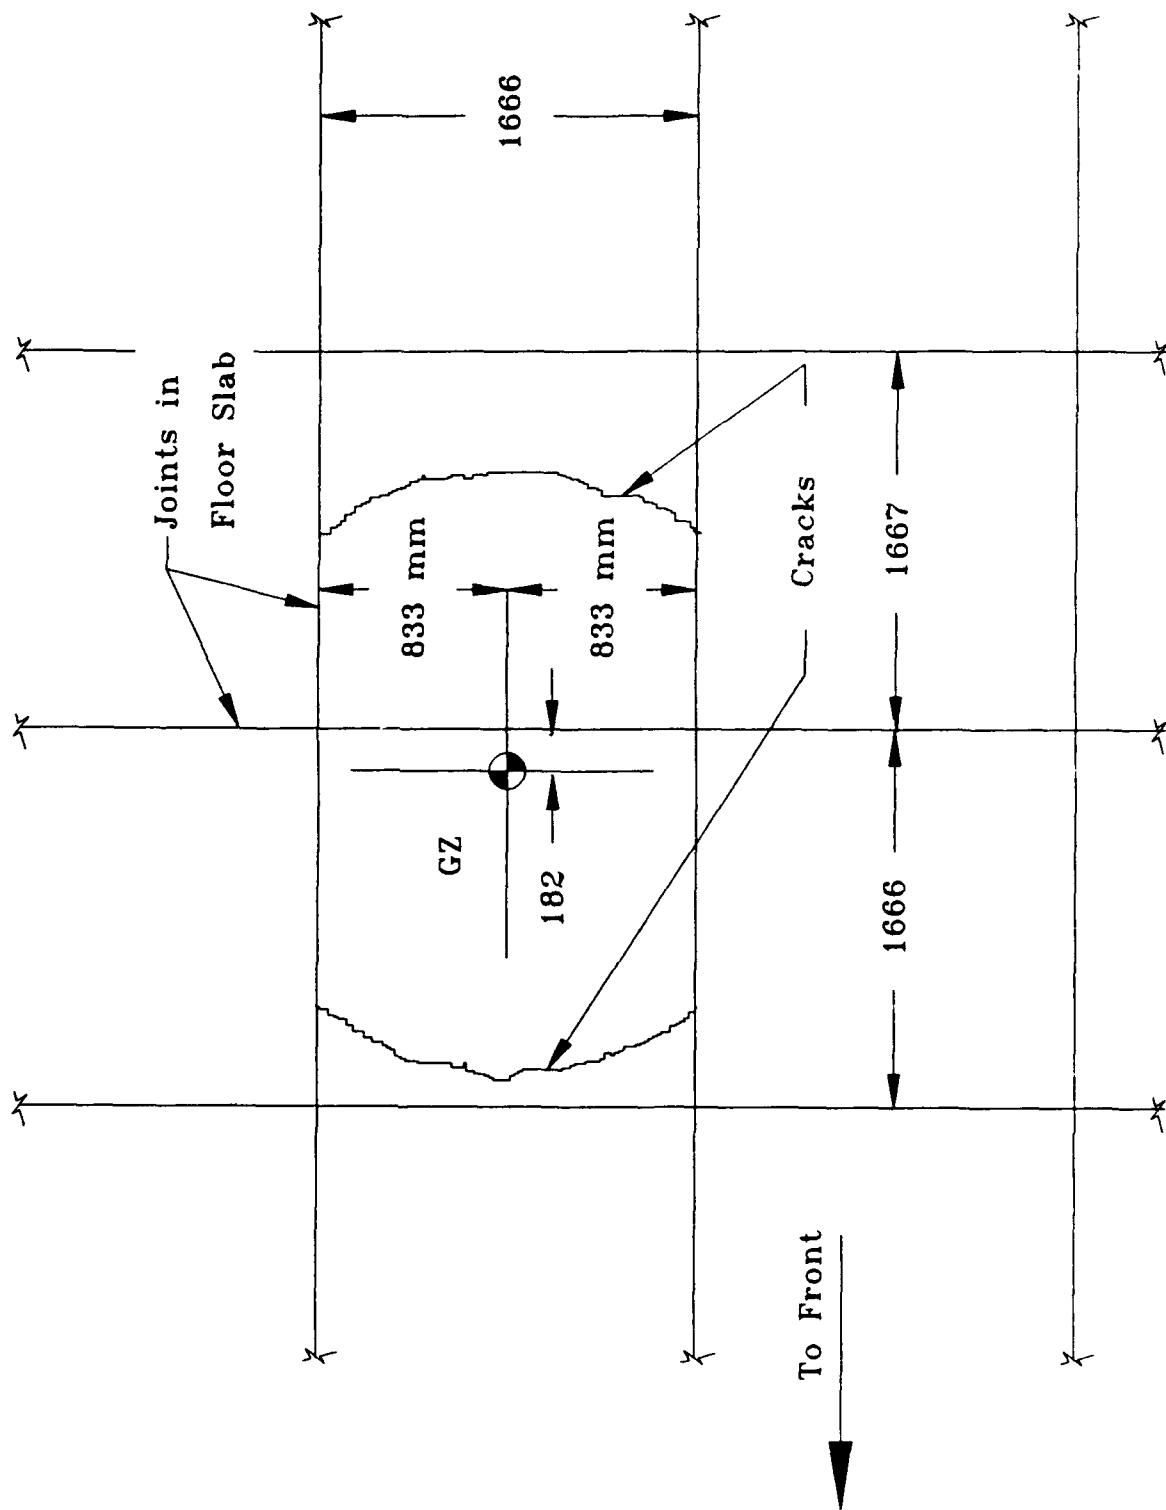
The pattern of hairline cracks shown in Figure 20 was observed in the floor slab around the surface GZ. Within these cracks, and the construction joints, the floor slab was "dished" downward to 18 mm at the GZ.

Figure 20. Crack pattern in floor slab, around GZ, PAS-1.

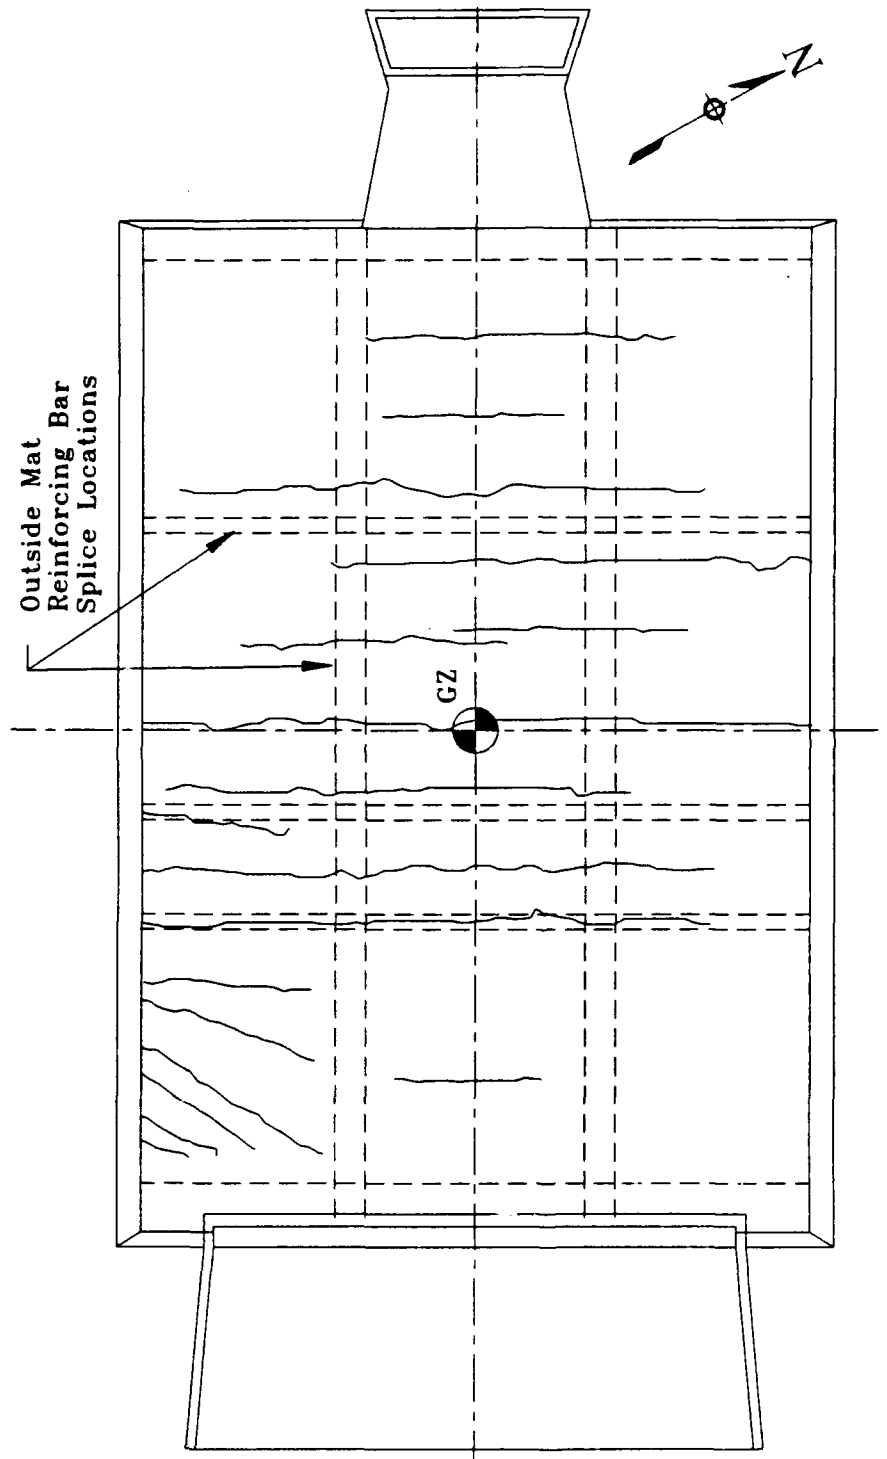
Figure 36. Crack pattern in arch, PAS-1.

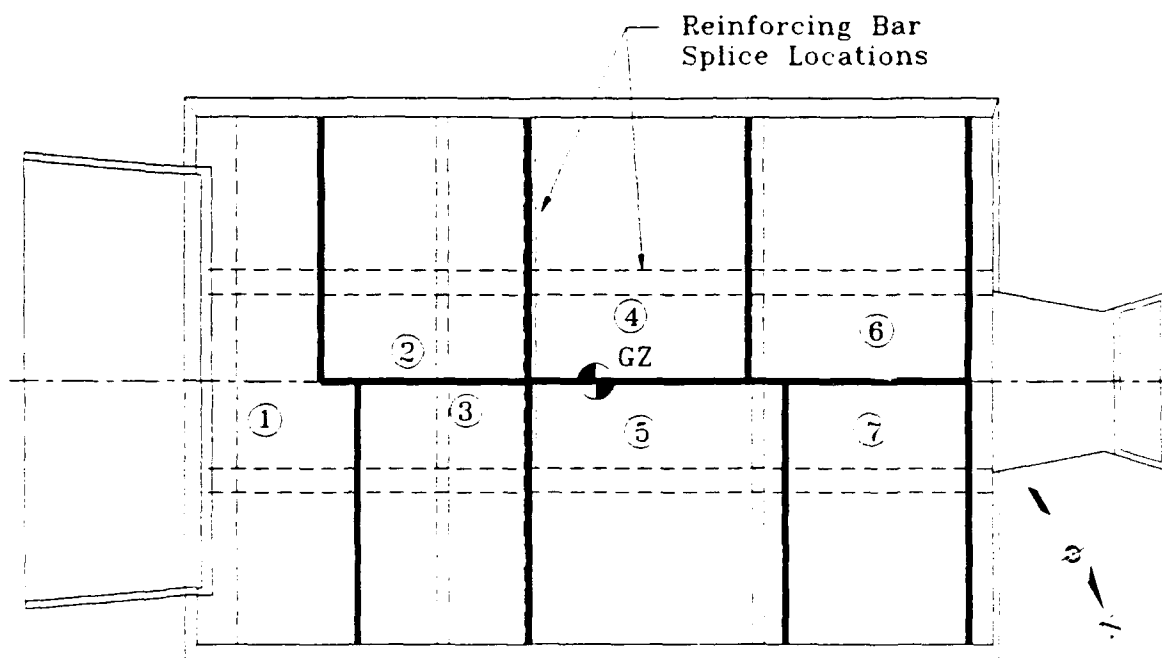
Figure 84. Breakup of the arch, PAS-3.

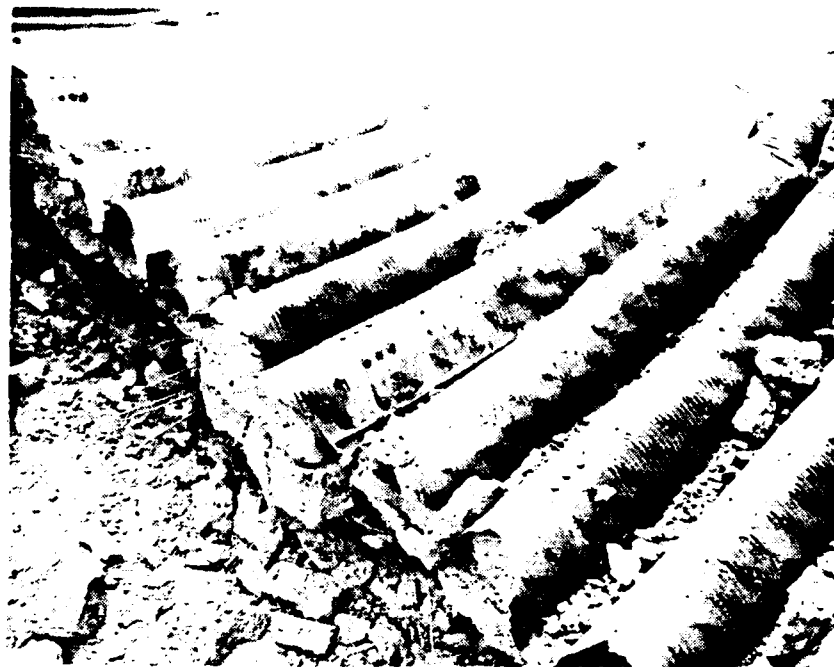
Figure 90. Longitudinal failure plane, PAS-3.

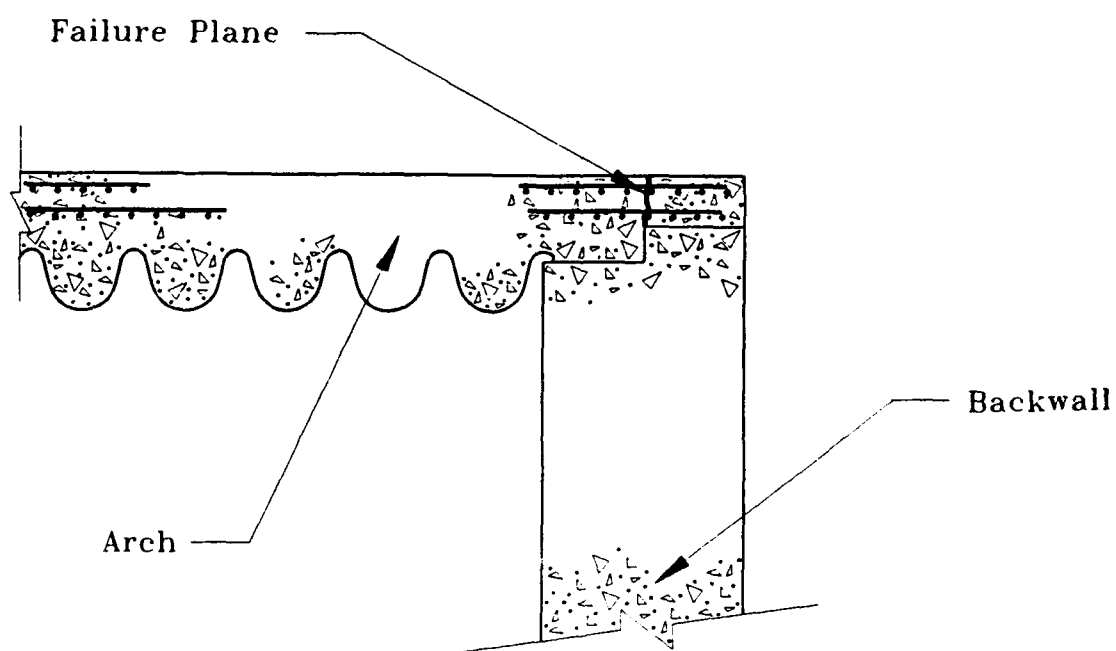
Figure 95. Section: Failure plane between the arch and backwall, PAS-3.

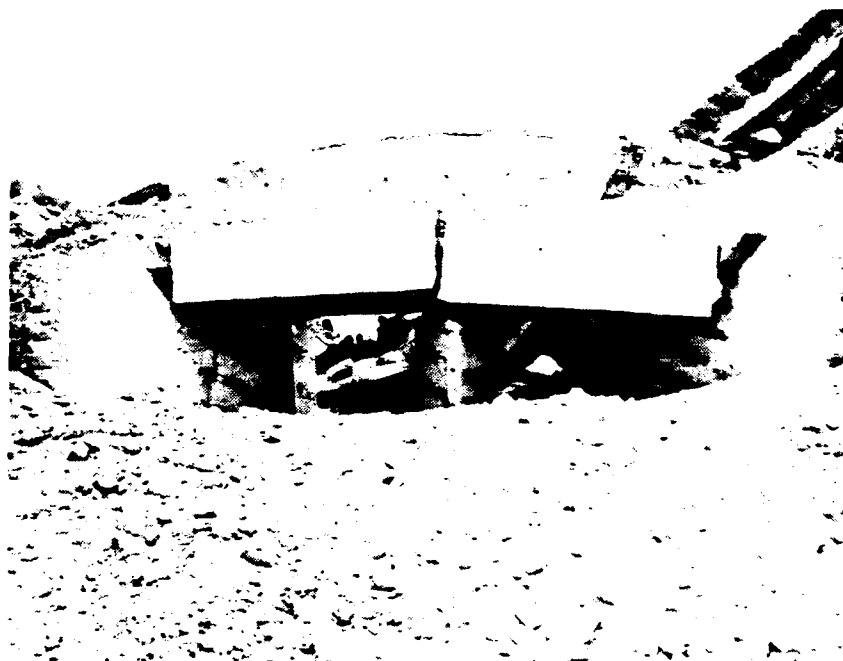
Figure 100. Posttest condition of exhaust port, PAS-3.

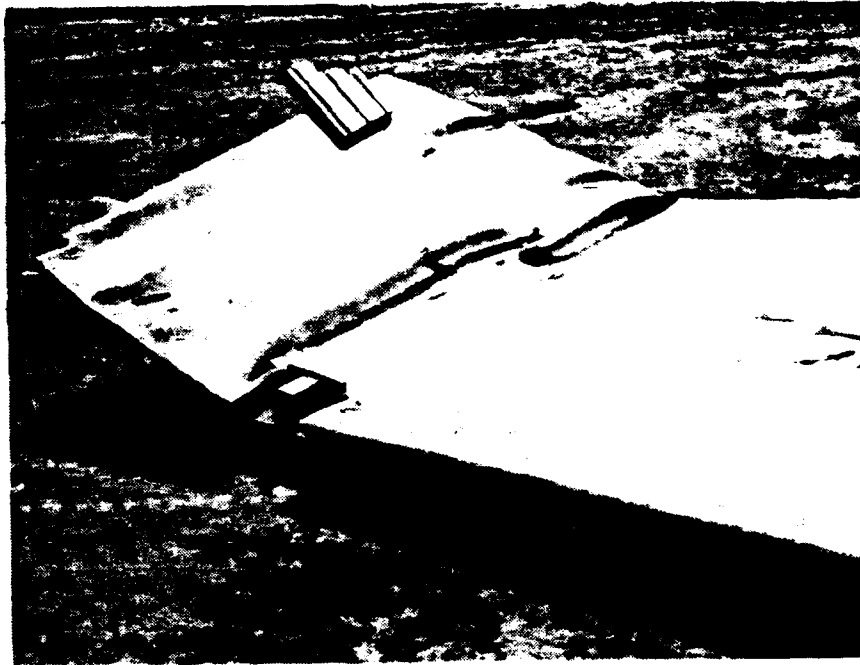
Figure 151. Bent ends of front door, PAS-2.

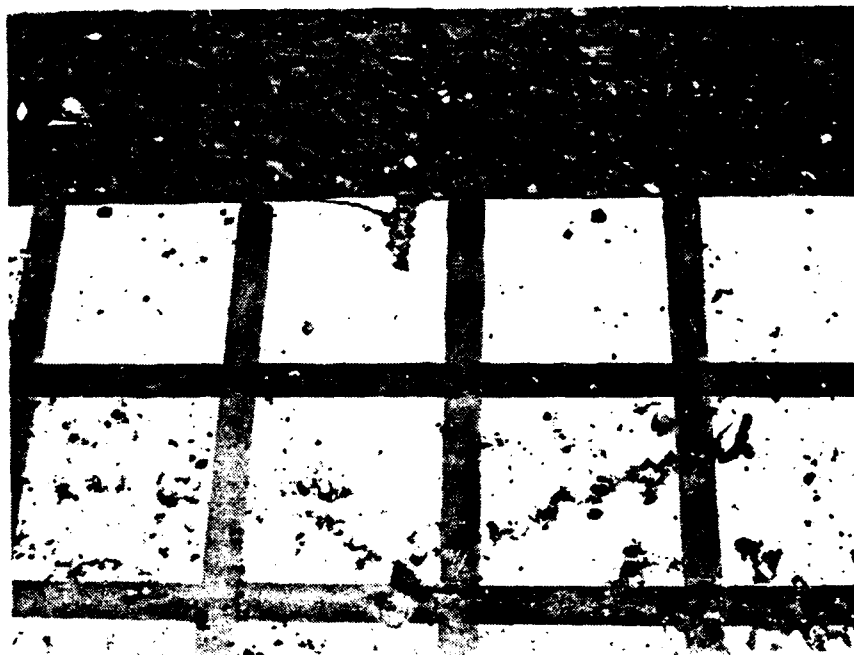
Figure 154. Impact damage to edge of apron slab, PAS-2.

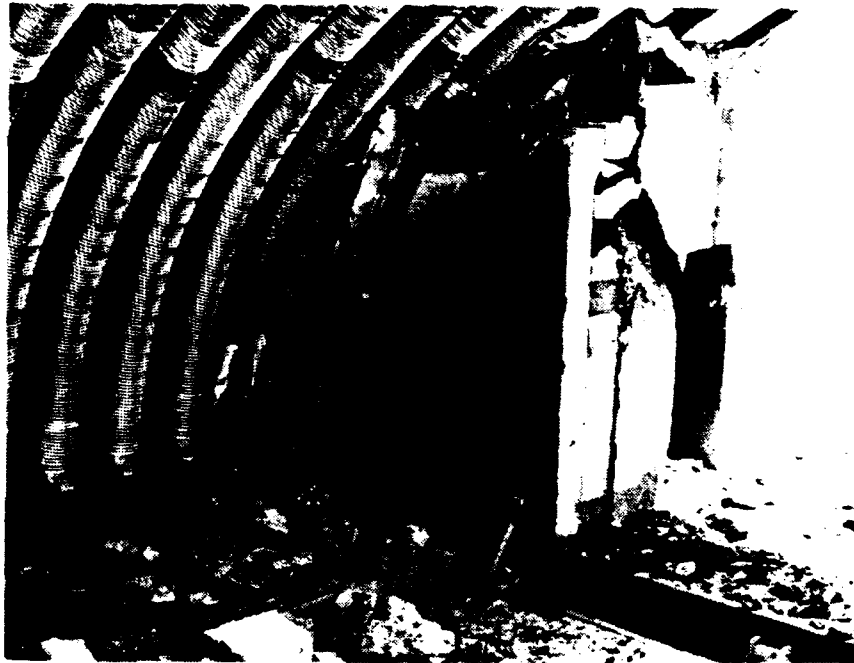
The front walls remained attached to the foundation, but the top of the headworks and the parapet broke away from the front wall with the front arch section (Fig. 155). The separation in the headworks steel liner assembly occurred at or near the welded joint in the liner. In some instances the weld was broken, in others the failure occurred in the base metal of the liner. The door stop at the top of the door frame was broken off of the frame. A series of radial cracks were observed in the front face of the parapet (Fig. 156). The crack pattern was virtually identical to that observed in the PAS-1 test. The large crack at the center of the parapet is consistent with a flexure failure, and probably a result of the front section of the arch falling back onto the wingwalls. There did not appear to be any significant damage to the front wall foundation.

Figure 155. Posttest view of left front wall, PAS-2.

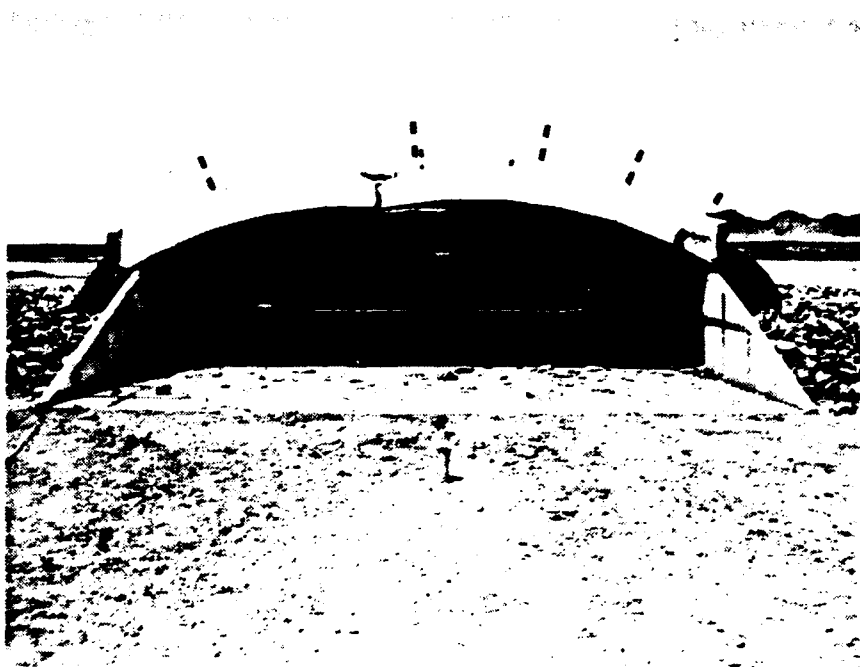
Figure 156. Crack pattern in front face of parapet, PAS-2.

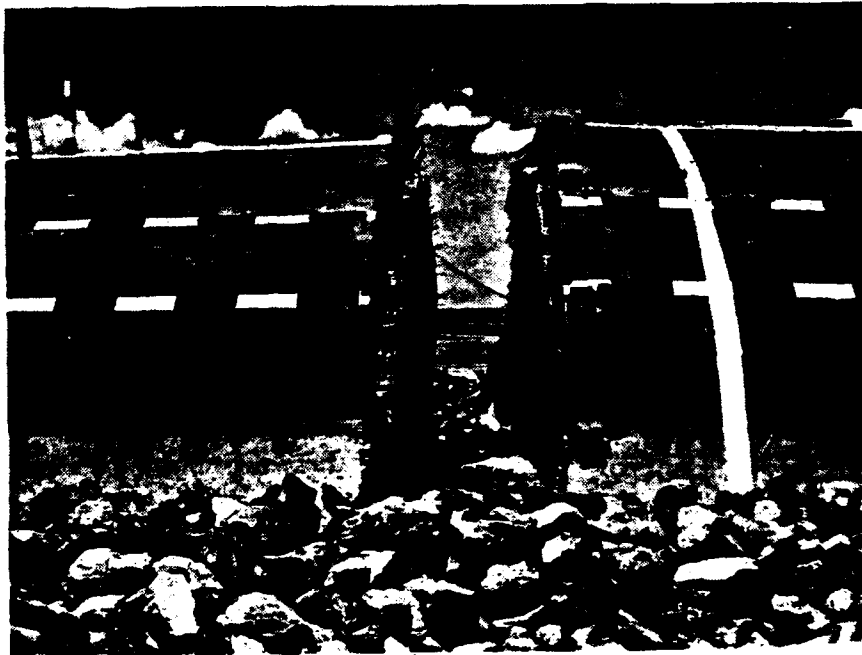
Figure 157. View of transverse failure plane in arch, PAS-2.

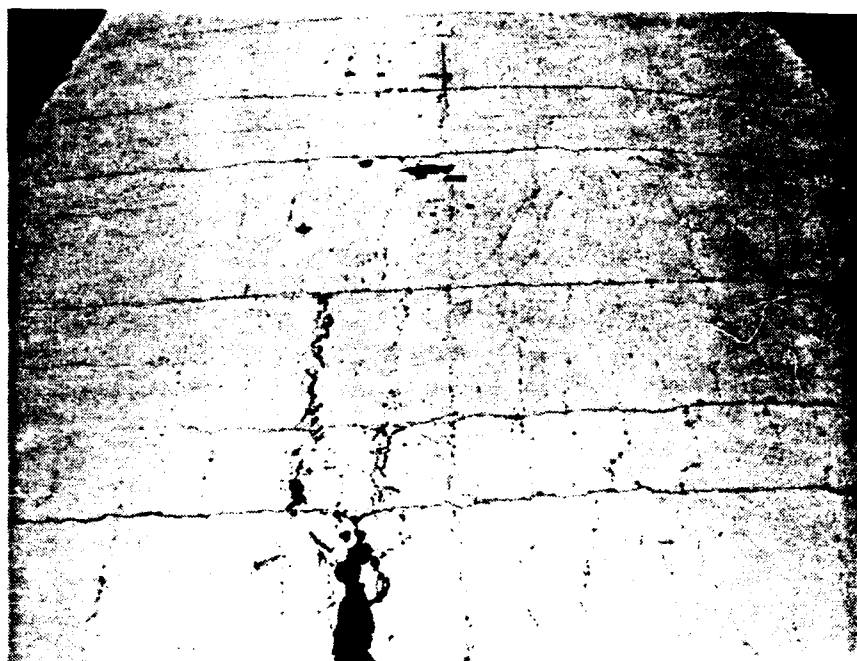
Figure 160. Transverse cracking pattern in arch, PAS-2.

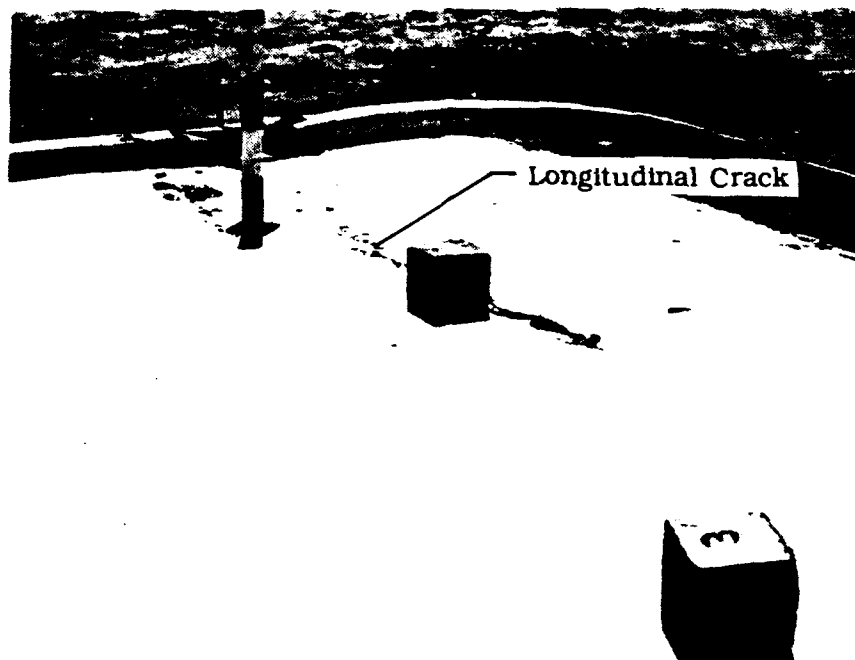
Figure 161. Longitudinal cracks at crown of arch, PAS-2.

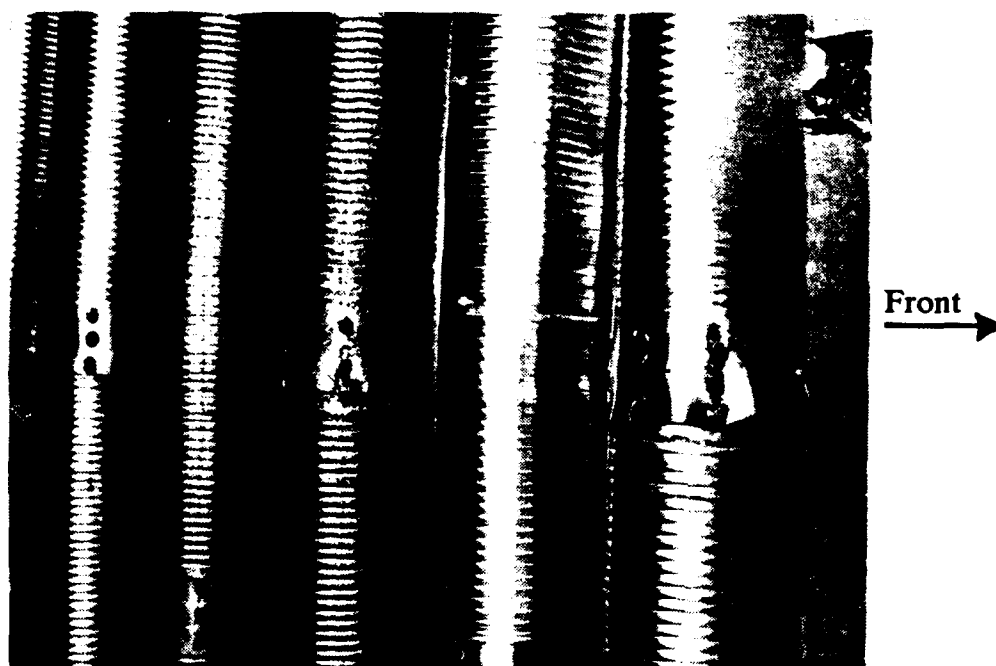
Figure 162. Condition of liner joints opposite longitudinal cracks, PAS-2.

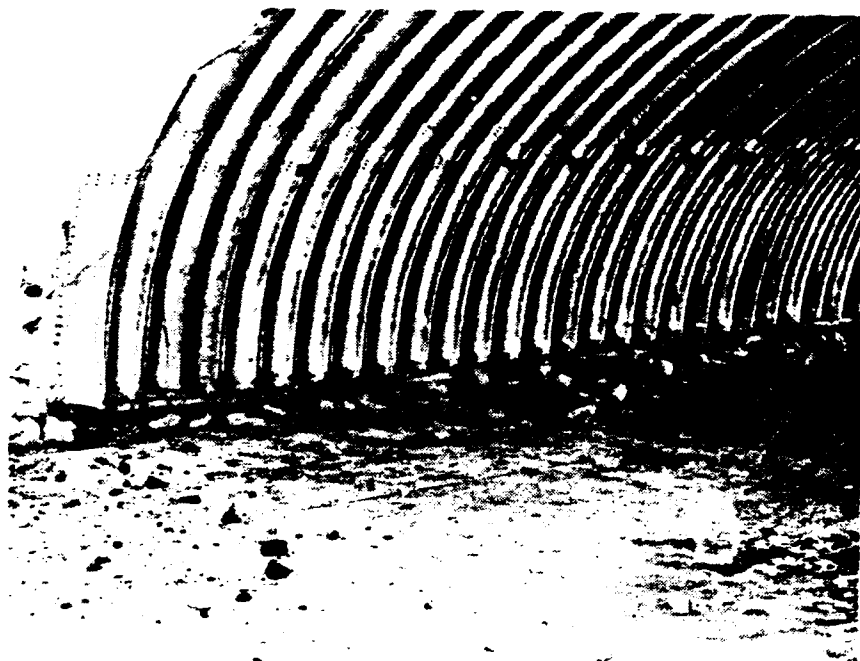
Figure 164. Arch resting on rock rubble, PAS-2.

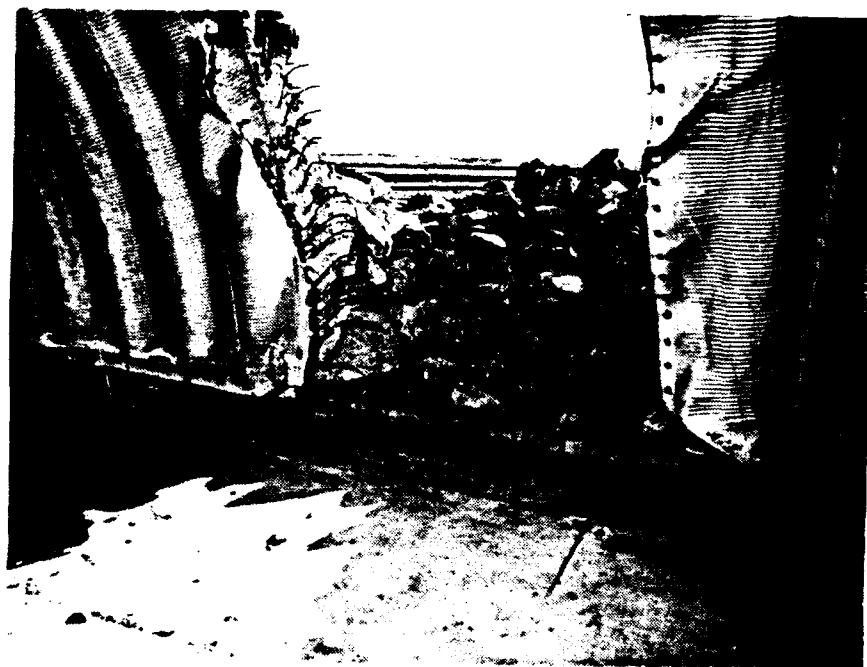
Figure 165. Broken dowel bars in arch foundation, PAS-2.

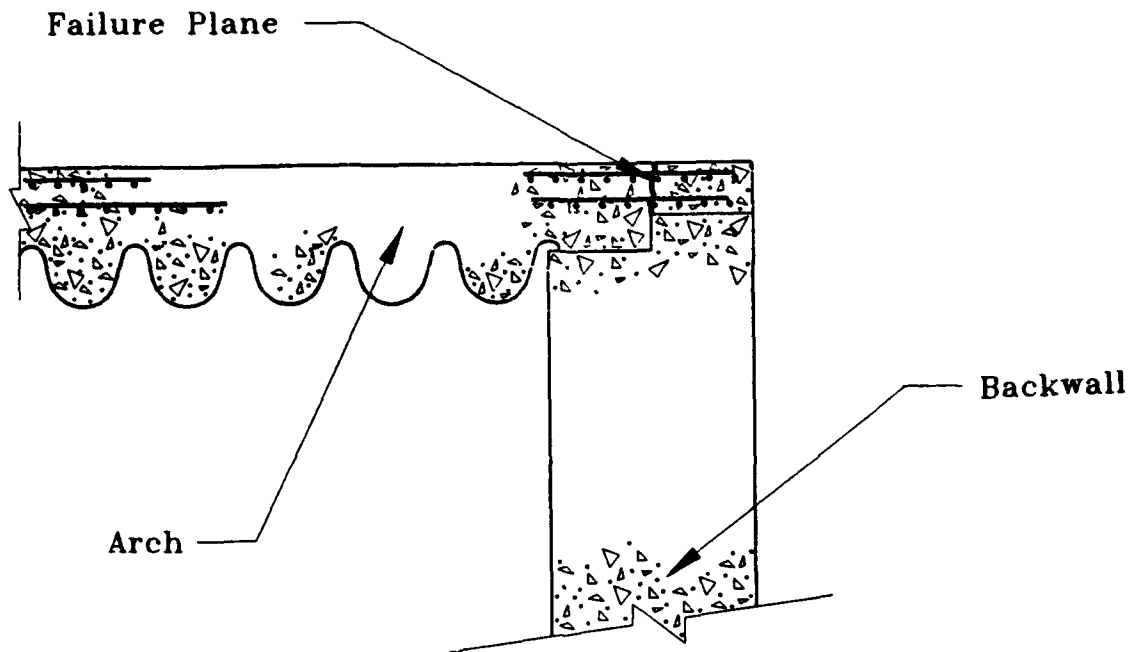
Figure 169. Section: Failure plane between the arch and backwall, PAS-2.

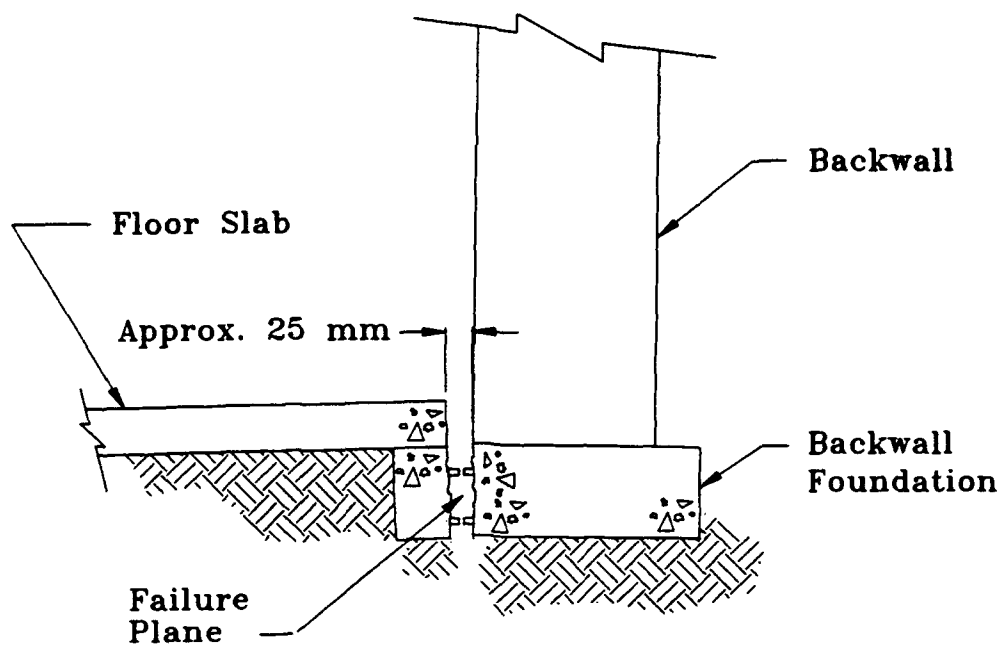
Figure 170. Section: Failure plane in backwall foundation, PAS-2.

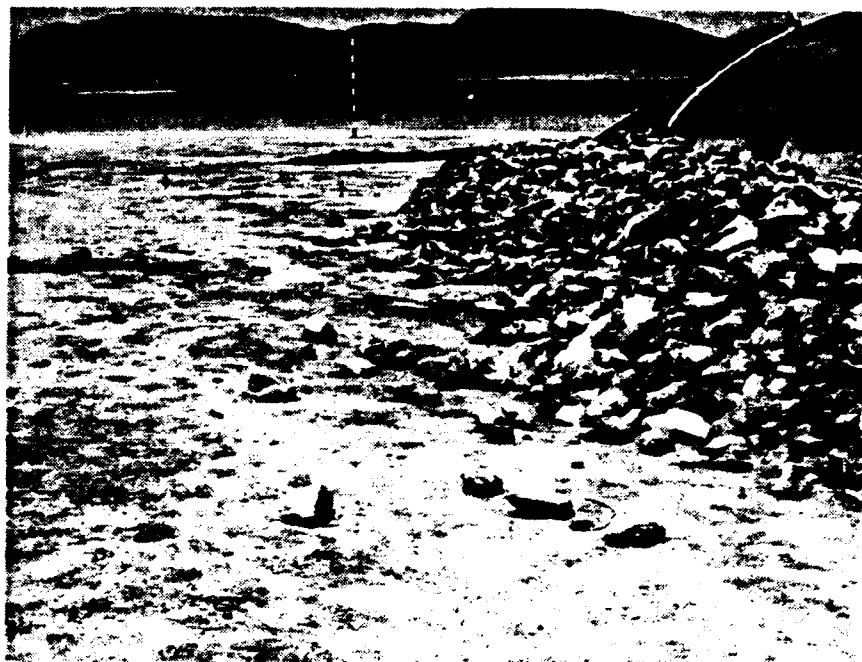
Figure 192. Rock rubble ejected from the berm, PAS-2.

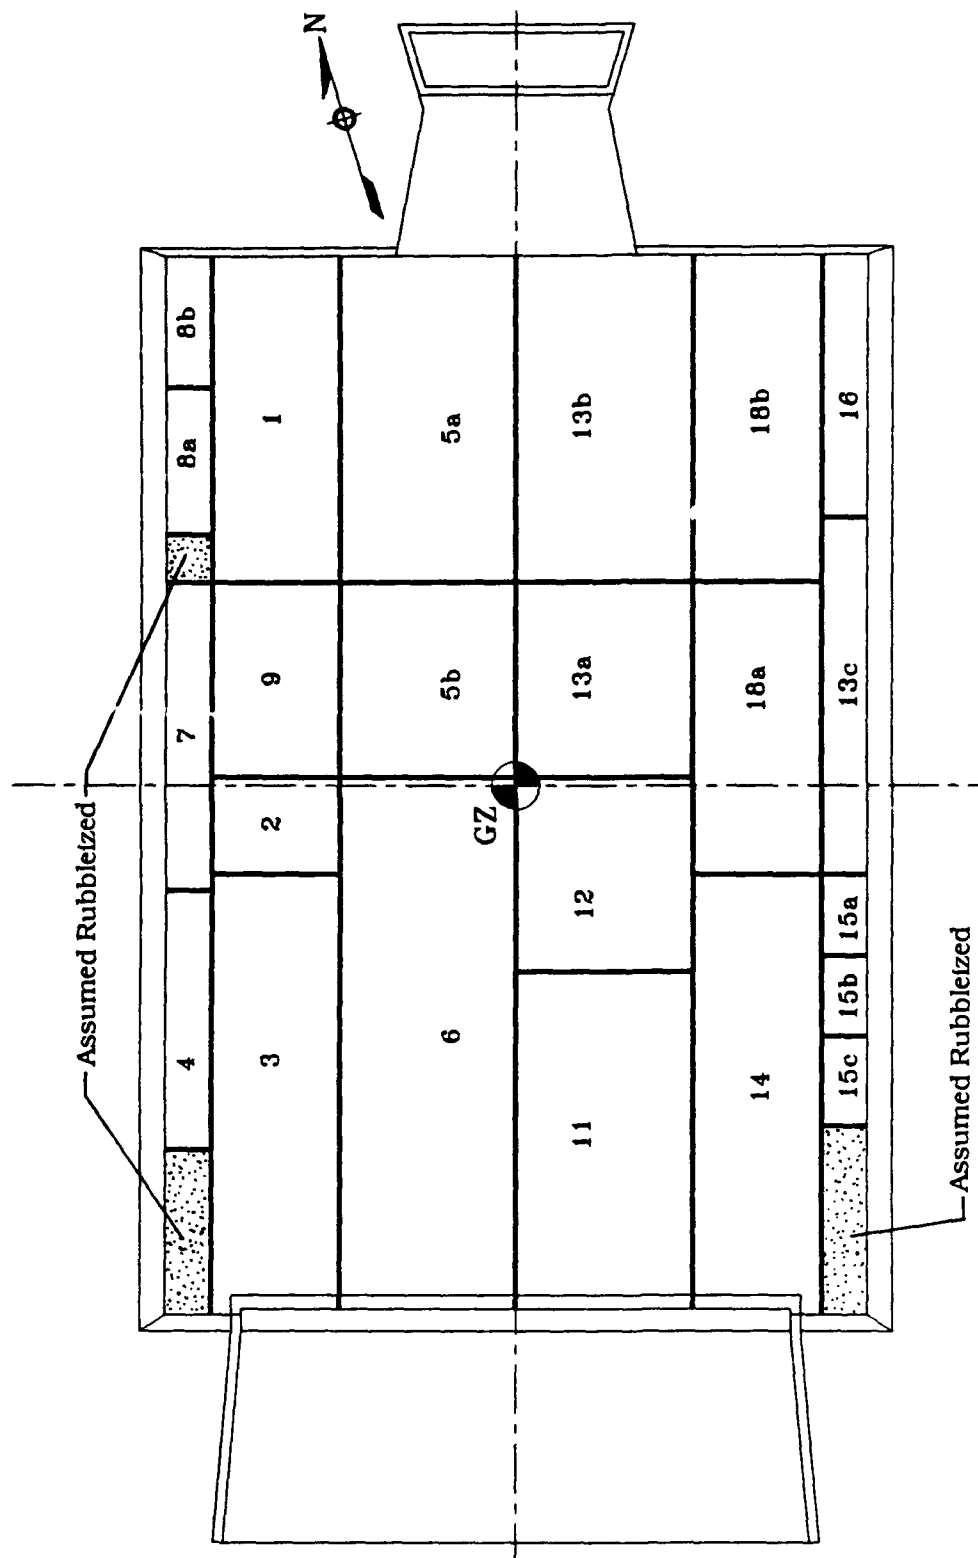
Figure 225. Crack pattern in arch, PAS-4.

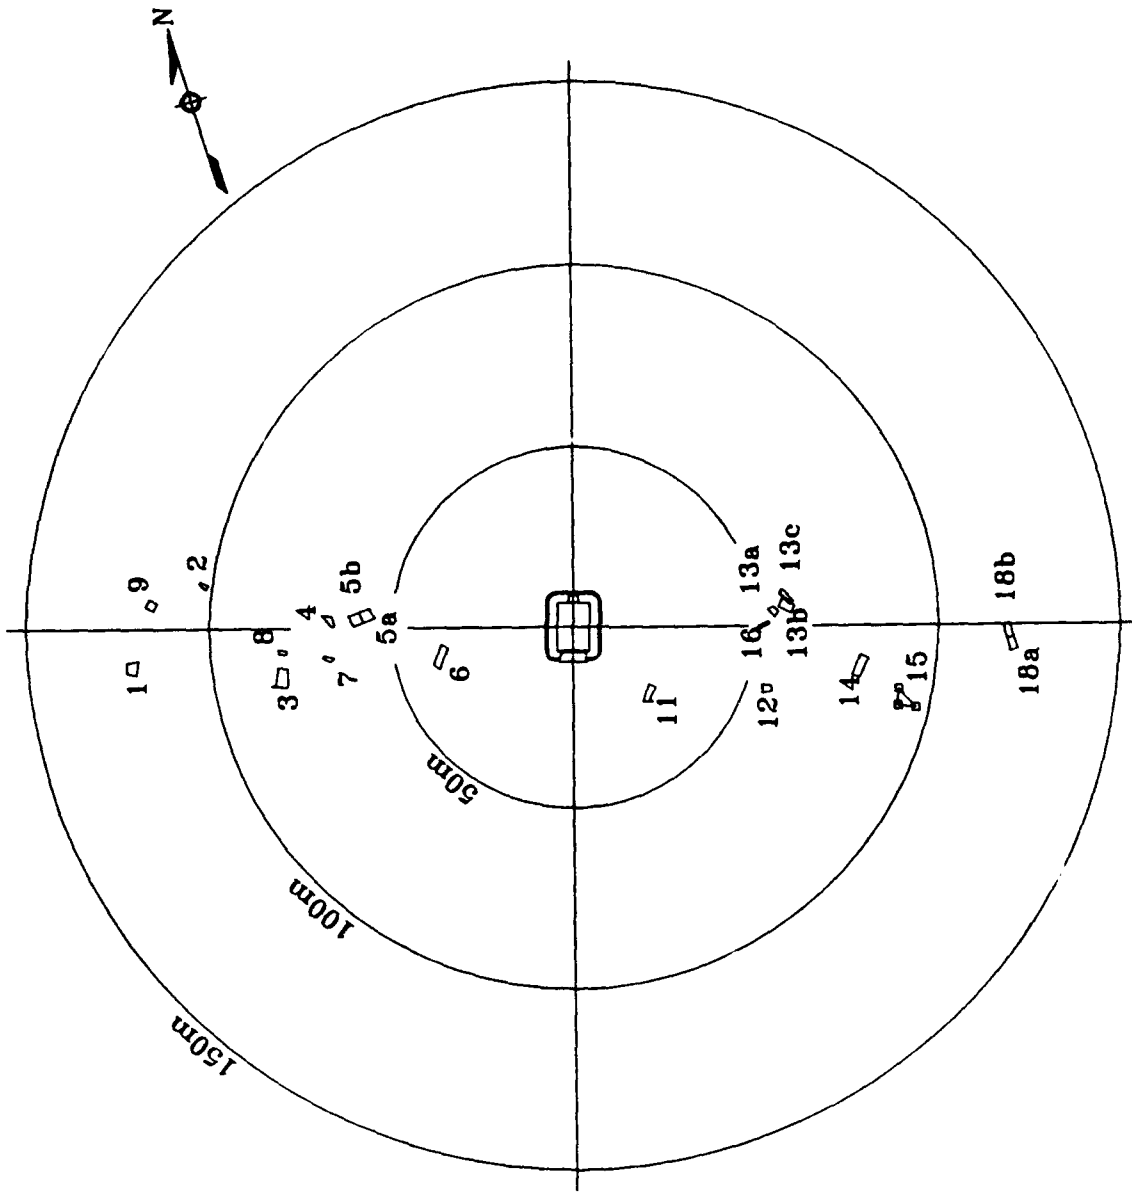
Figure 226. Posttest locations of large arch sections, PAS-4.

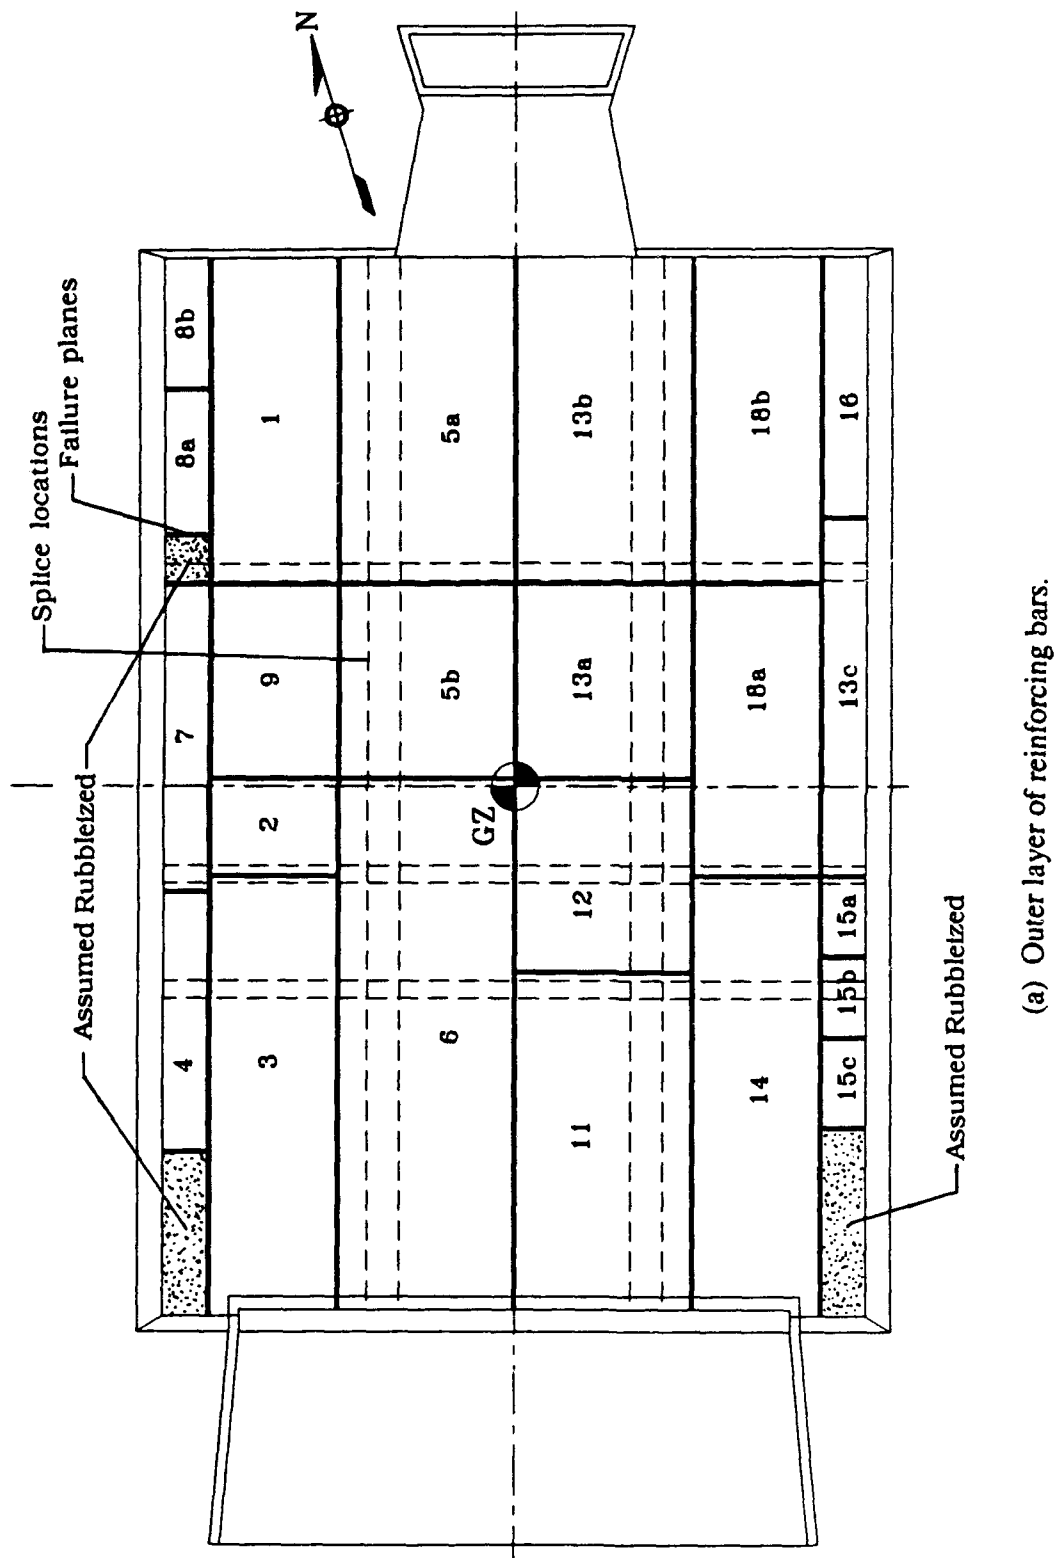
Figure 228. Failure planes and splice locations, PAS-4.

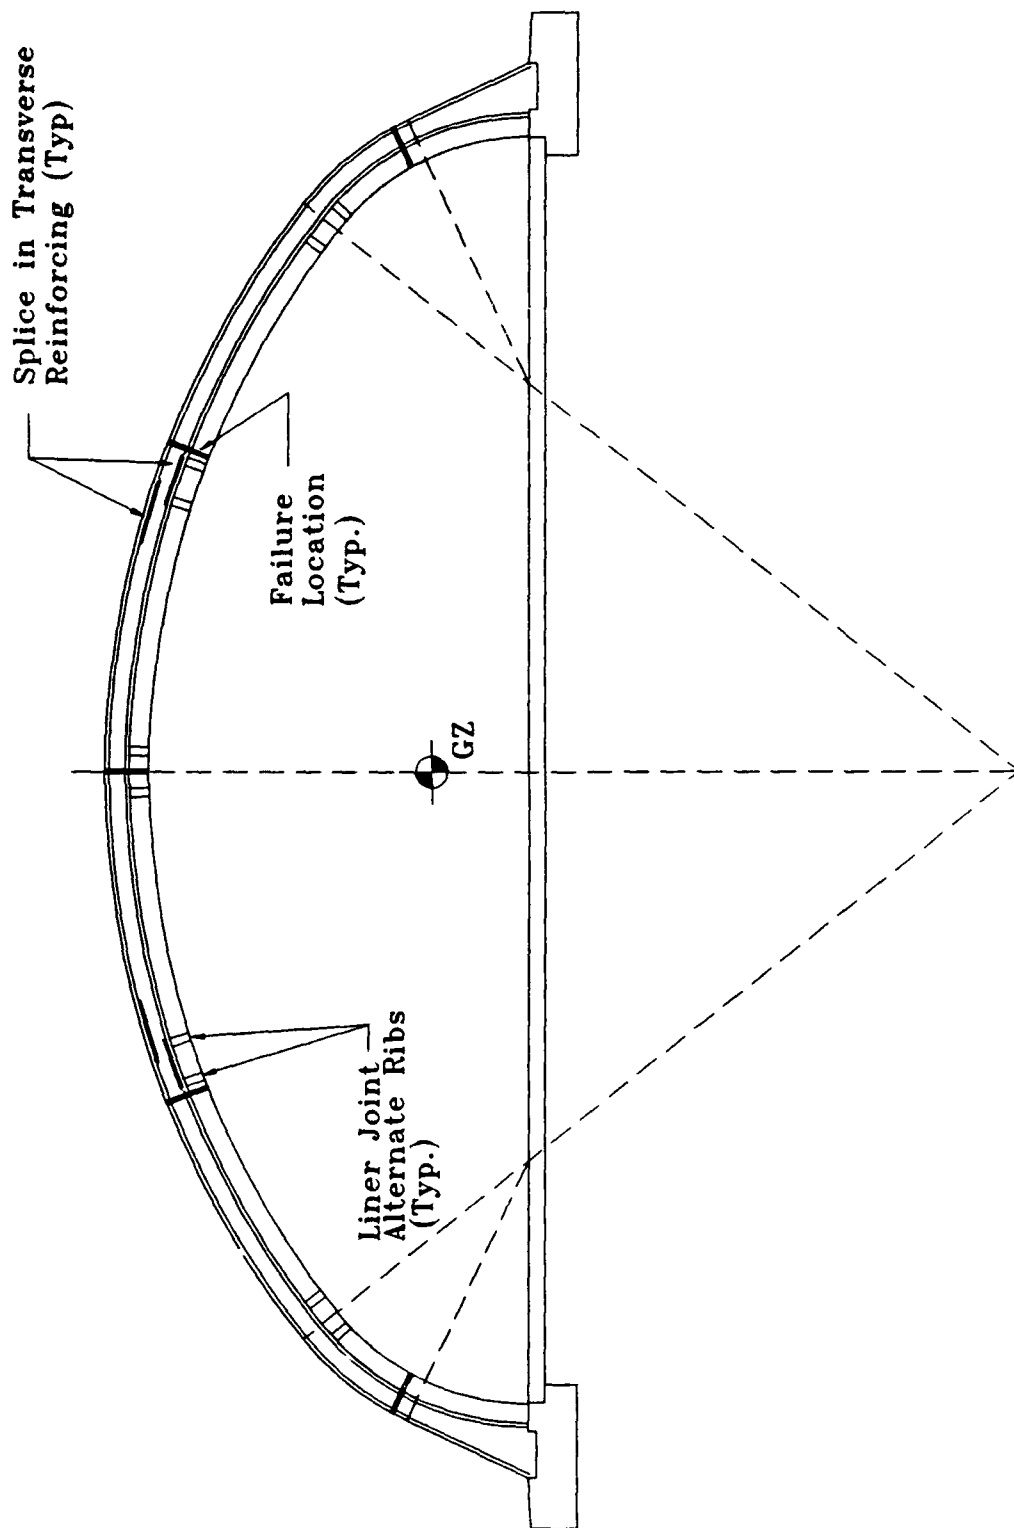
Five longitudinal failure planes in the arch were identified (Fig. 231). One of the longitudinal failure planes was along the crown of the arch. Two occurred at or near the splices in the transverse reinforcing bars. The remaining two were found at or near the location where the upper arch section begins to thicken near the foundation. At each of the failure lines, the corrugated liner material was ripped apart in tension (Fig. 232). Although the upper three failure lines occurred near the bolted joints between liner segments, the presence of the joints did not appear to influence the formation of the failure planes or the tearing of the liner. The liner was observed to have torn exactly at a bolted joint in only a few isolated locations. At the longitudinal failure plane, the concrete failed in tension. Along the failure plane at the crown and at

Figure 231. Locations of longitudinal failure plane, PAS-4.

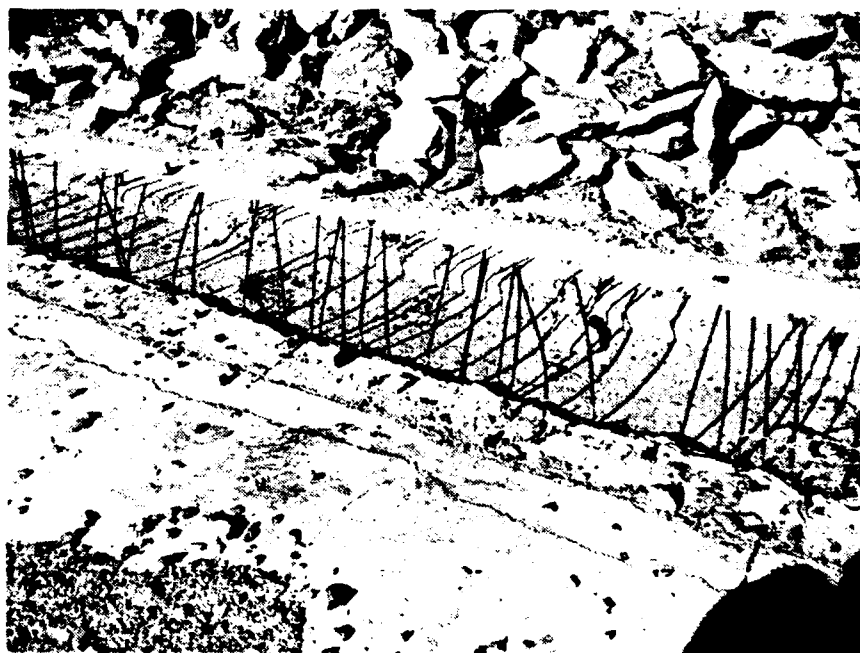
Figure 238. Broken dowel bars in top of arch foundation, PAS-4.

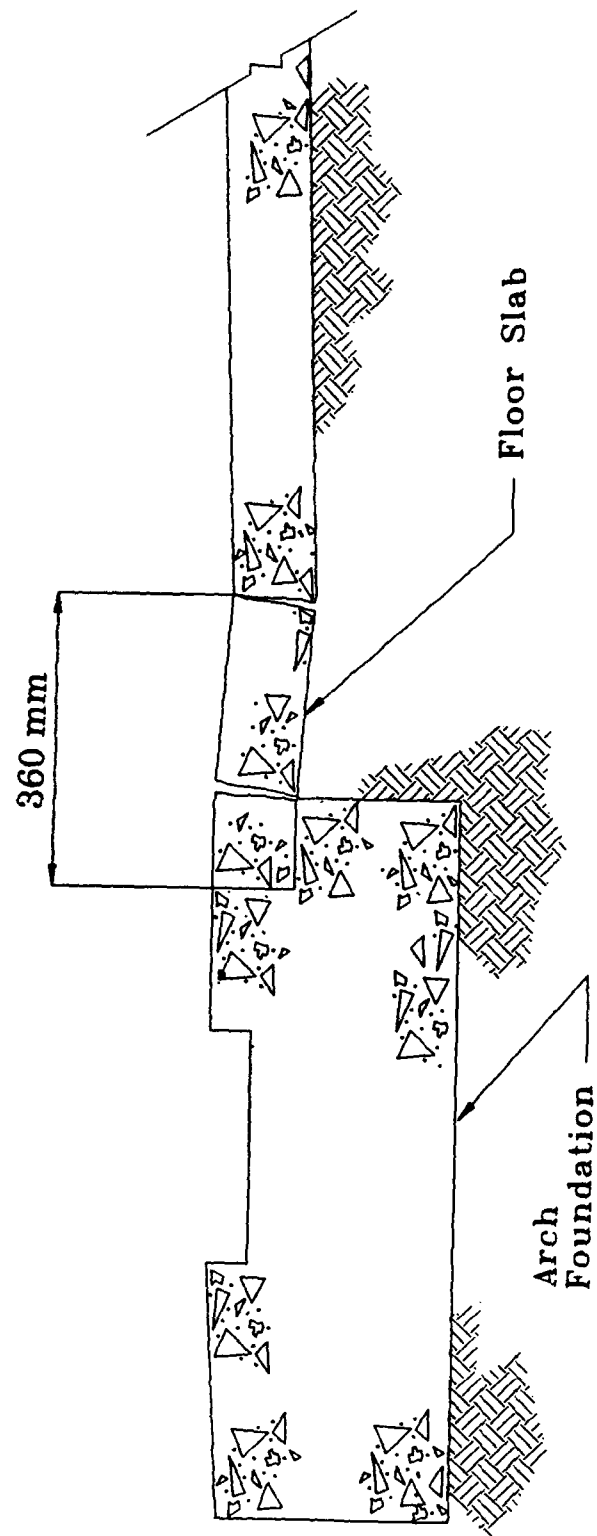
Figure 240. Section: Crack pattern in floor slab at arch foundation, PAS-4.

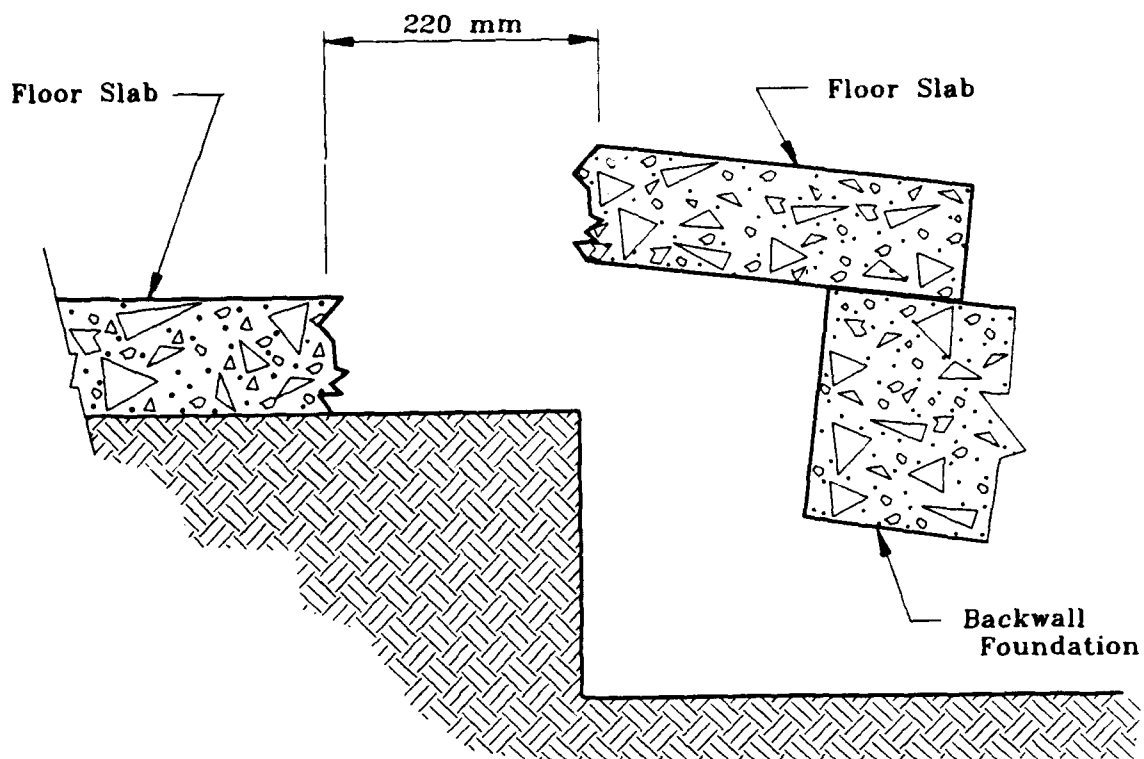
Figure 243. Crack pattern in floor slab at backwall foundation, PAS-4.
